Figure 7 - Potential Monitoring Well Locations
 PCE Plume Evaluation - Unit Well 8
 SCS Project 2521516.00

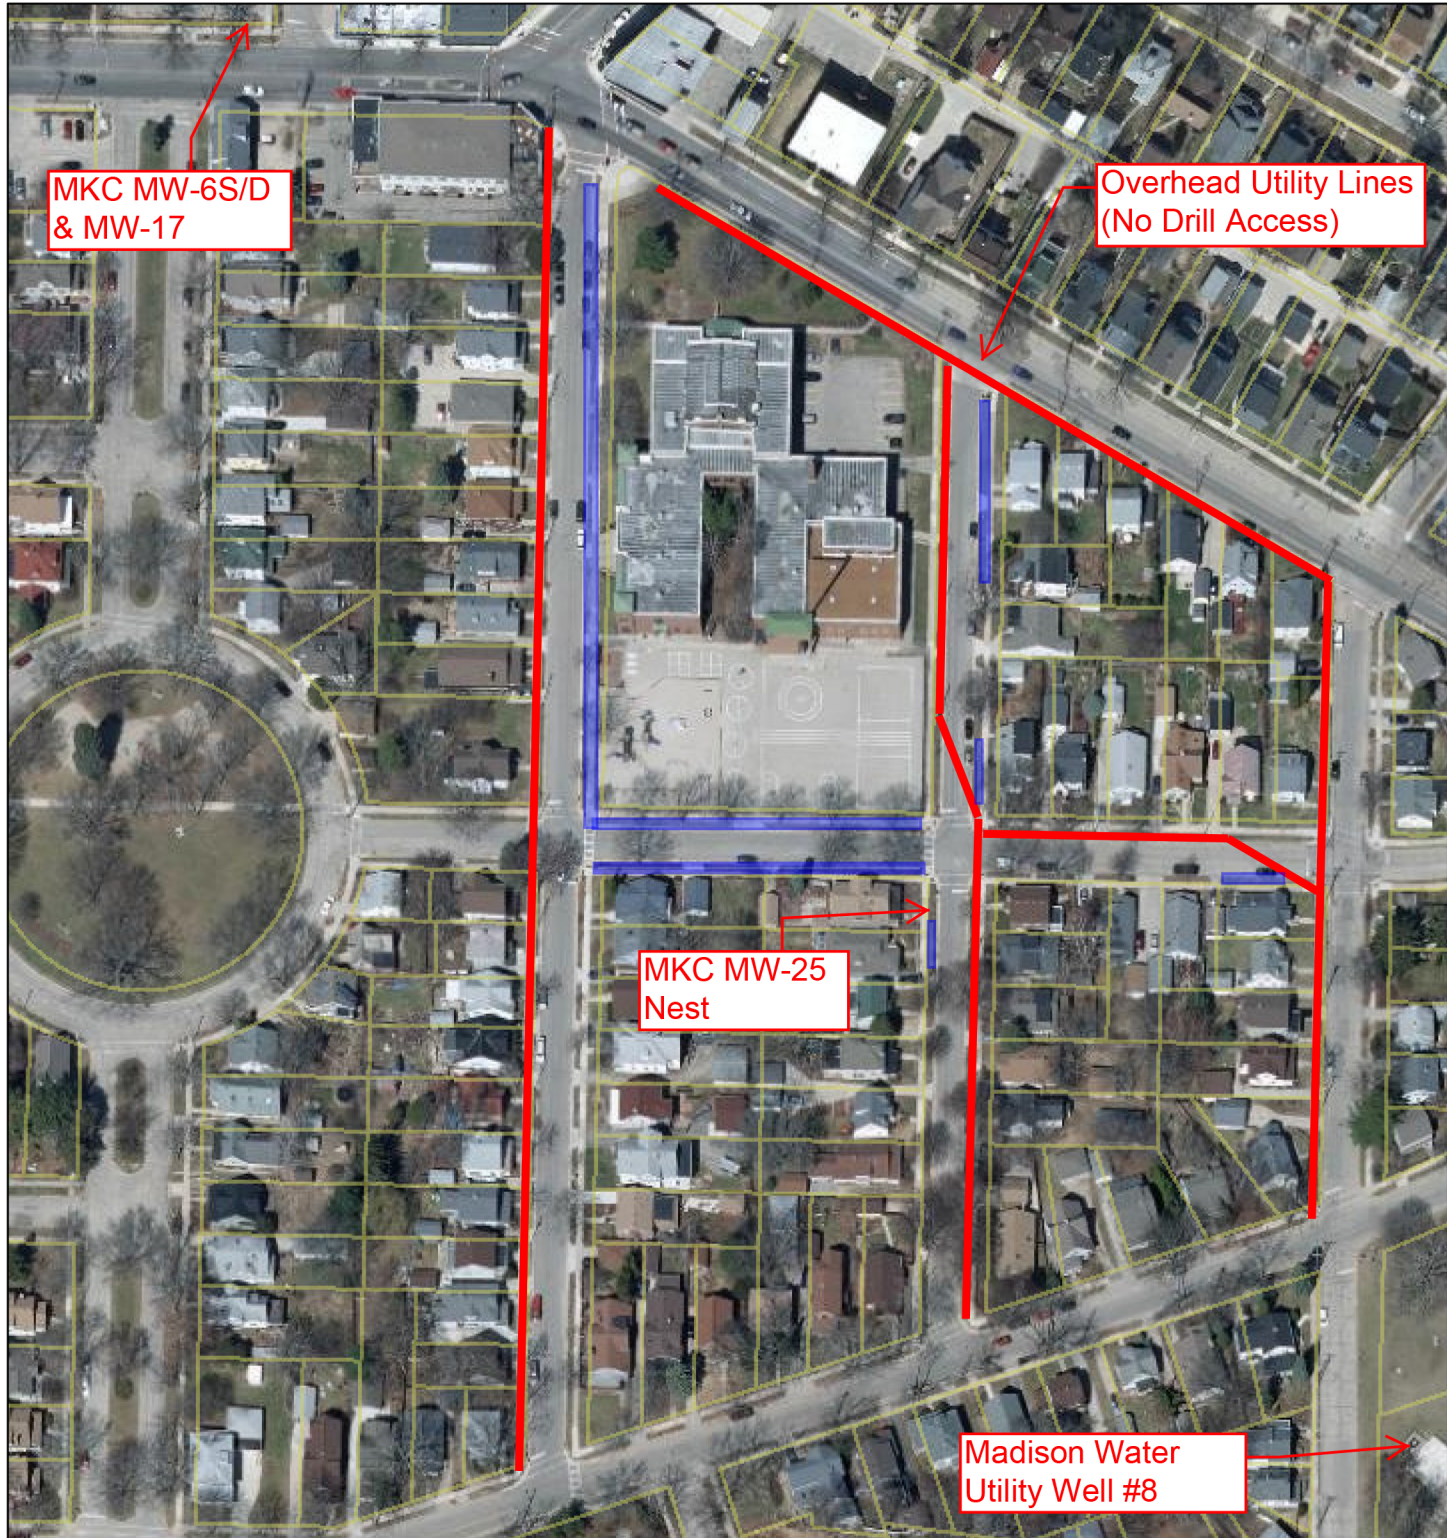
Potential Well Locations Along Likely Contaminant Flow Paths That Are Not Obstructed by Terrace Trees or Overhead Utilities are Shown in **Blue**
